June 2024

# Franklin Street Sites - Facility Assessment

Hancock MI, 49930

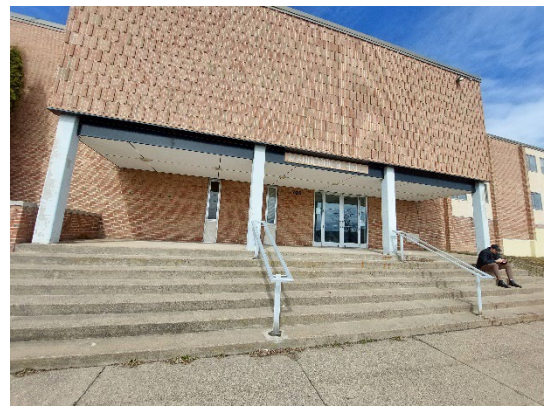
The majority of the building is faced with brick masonry and EIFS/Stucco. There are some small areas of brick which show efflorescence and some small areas in need of re-pointing. The kitchen addition is the area that has the most concern regarding the condition of the brick. It is apparent that there has been water issues and attention is needed at the scupper locations where there has been a severe degradation of the mortar joints. There is some cracking visible and some joint deterioration in the EIFS/Stucco. The EIFS/Stucco was not the original cladding of the building and the exact construction of the wall system in these areas is unknown.

Insulation in the wall system is unknown but does not appear to be adequate per current standards and code requirements.

Overall, the exterior wall system requires some maintenance, but is functional and has over 10 years of life.

Perform maintenance at building exterior, replacing existing sealants. Re-point damaged areas of brick especially at kitchen addition. Install conductors at the scuppers from the kitchen addition roof to avoid further damage to the brick surface.

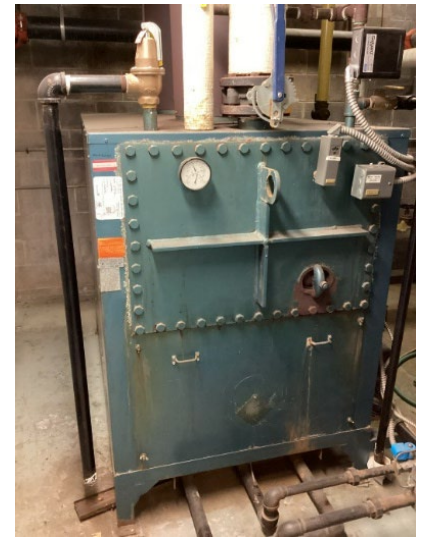
The building's heating system consists of a 2,000 MBH hot water Rite boiler that was installed in 1988. The unit is still in good operating condition but is approaching 40 years of service. The boiler also feeds the Nikander Hall addition hydronic mechanical equipment. The pumps located in the mechanical room are still in good condition. The heating distribution piping is a combination of schedule 40 black pipe and copper pipe. The offices, classrooms, kitchen, and dining hall are heated with convectors and finned tube radiation and about half of them are currently working. The convectors and finned tube are controlled in zones so each room does not have individual control. Two unit ventilators provide ventilation air for the kitchen and dining hall but have been taken out and ductwork has been disconnected. All ductwork and diffusers in the kitchen and dining hall have been left in place. A unit ventilator, that is not operational, on the ground floor provided ventilation air to multiple rooms. There is currently no ventilation air being provided to the building. The restrooms have exhaust ductwork connected to powered roof/ceiling exhaust fans that were not operating while onsite.

The compressor for the pneumatic control system looks to be original to the building. The air lines are in place and operational. The compressor has been running continuously during every visit. It seems there may be a leak in the system.

Replace the boiler and pumps. Replace the nonfunctioning convectors and finned tube radiation. Add ventilation to the spaces in the building as required per code. Replace exhaust fans or add energy recovery units for the restrooms. Remove pneumatic control system and replace with a digital control system.

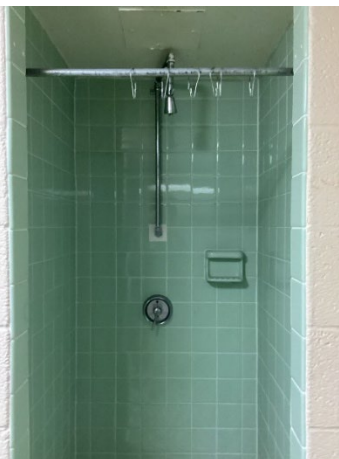
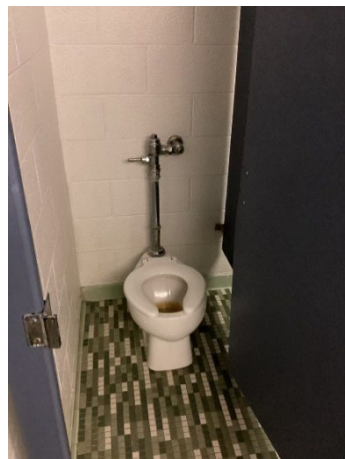
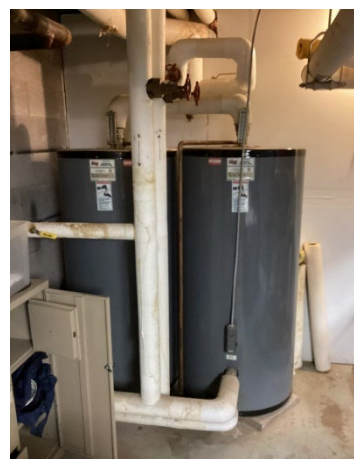
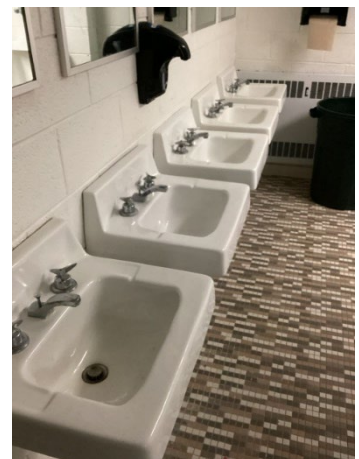
There are six gang toilet rooms, three men and three women, throughout the building that include lavatories, water closets, urinals, and showers. The ground floor has an additional men's and women's restroom. The first floor has a restroom off the kitchen that includes a lavatory, water closet, and tub/shower. All plumbing fixtures are original to the building and are in poor condition. The water closets are floor mounted with manual flush valves and the lavatories are a combination of manual and sensor faucets. There are two laundry rooms, each with washer hookups and a sink. There are five janitor closets, each have a mop sink.

Replace all fixtures. Replace roof drains when roof is replaced and add overflow drains. Review the condition of the domestic water and sanitary piping. Replace the hot water storage tanks with storage water heaters. Add fire suppression piping and sprinkler heads to the building.

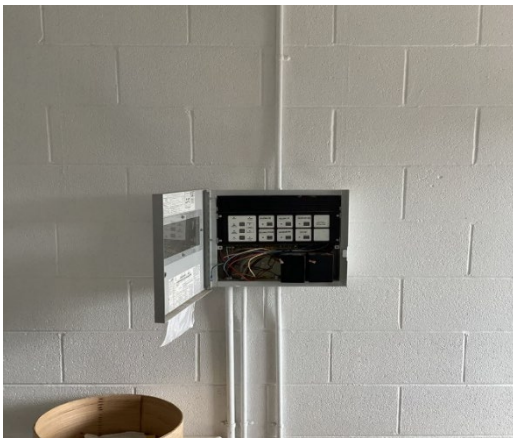
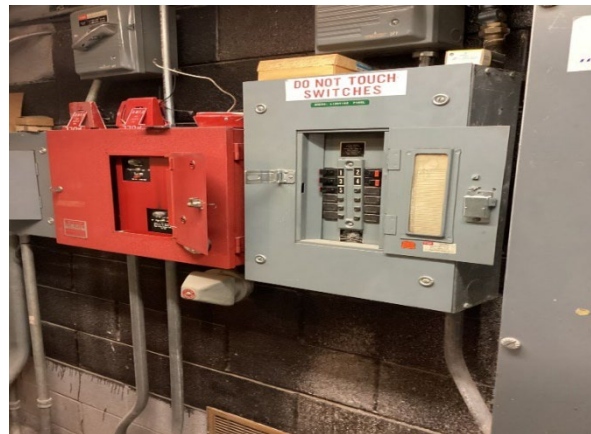
Each dormitory room and the corridors contain standalone battery-operated smoke detectors. None of the devices tested during our walk through were in working order.

**Recommendation:** The fire alarm system is past its useful life. Install a new addressable fire alarm and detection panel, replace input and notification devices, and add devices where needed to bring the system up to current codes.

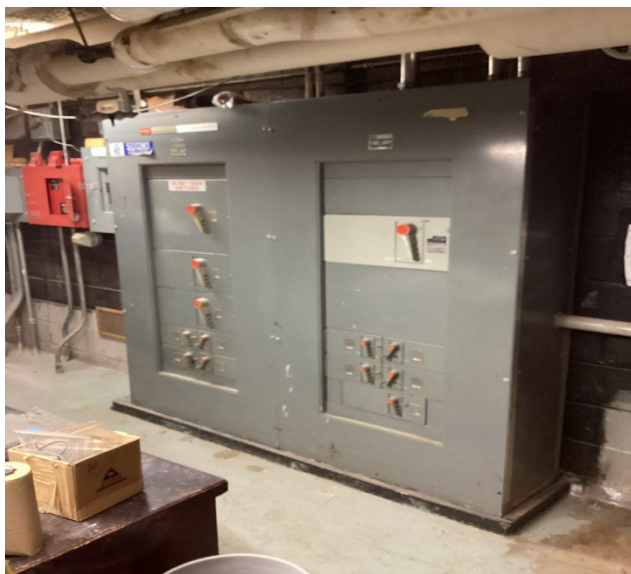
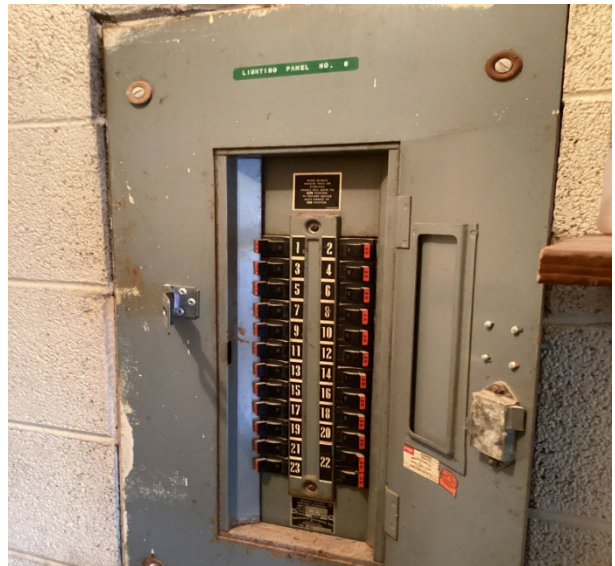
Multiple 100A and 200A main lug only federal pacific branch panels are placed throughout the building to feed receptacle and lighting branch circuits. These panels are original to the building.

**Recommendation:** The 600A main service panelboard is close to 60 years old and past its service life. This panelboard should be replaced as replacement parts will not be readily available. The Federal Pacific branch panels are also 60 years old and past service life. This brand is known to cause fires due to the breakers not tripping during overload conditions. Replace all panelboards in original locations with new.

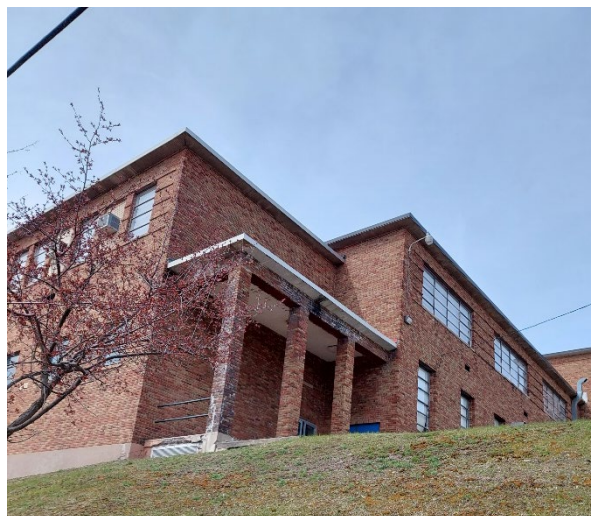
The majority of the building is faced with brick masonry. There are some small areas of brick which show efflorescence, especially at the east portico, and some visible cracks in need of re-pointing. There is also damage evident at the terrace where a portion of wall was removed.

Perform maintenance at building exterior, replacing existing sealants. Re-point damaged areas of brick especially at east portico.

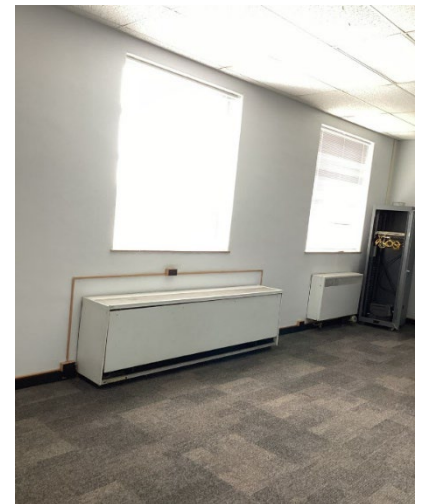
The majority of the first floor has an air handling unit (AHU) with duct heating coils that are fed from the hot water boilers in Mannerheim Hall. The pumps are located in the mechanical room in Nikander Hall and some of the hydronic piping requires patching or replacement. The AHU includes heating, cooling, and ventilation and the unit was not in operation during the walkthrough. The cabinet unit heaters and unit ventilators located throughout the building are served by a steam boiler located in the Wargelin Hall boiler room. There is some ductwork and grilles/diffusers on the second and third floor, but it is unknown where the unit is located or if it is operational. Some rooms have wall mounted A/C units. There are grilles in each of the toilet rooms ducted to exhaust fans.

The compressor for the pneumatic control system looks to be original to the building. The air lines are in place, but it is unknown if they are operational.

Verify the age of the AHU’s and if they are operational. Verify they are sized appropriately for the spaces and there is adequate ventilation. Add new units and replace existing units as needed to meet ventilation requirements. Remove the steam piping throughout the building and cap the pipes where they come from Wargelin Hall. Remove and replace all convectors. Add boilers and pumps to the mechanical room in Nikander Hall and route new hydronic piping to heating coils and convectors. Remove all pneumatic controls and air lines and replace with a digital control system.

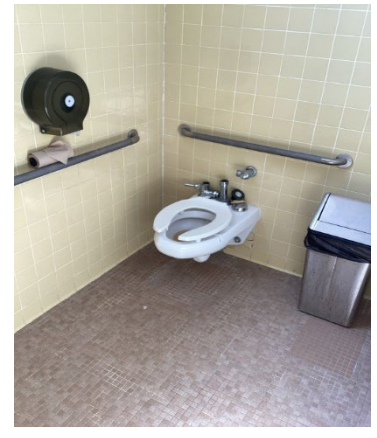
There is one woman and one men gang toilet room on the first floor, a single men and women toilet room on the third floor, and a single unisex toilet room on the second floor. The toilet rooms include a mixture of floor and wall mounted water closets with manual flush valves, urinals with manual flush valves and lavatories with a mixture of sensor and manual faucets. The fixtures appear to be in good condition, but the flush valves have been dismantled to avoid freezing during winter. There are no janitor closets.

Fixtures can be salvaged as they are all in good condition. Replace roof drains when roof is replaced and add overflow drains. Review the condition of the domestic water and sanitary piping. Verify the water heater is sized adequately and replace if needed. Add fire suppression piping and sprinkler heads to the building. A separate water main would need to be added with a meter.

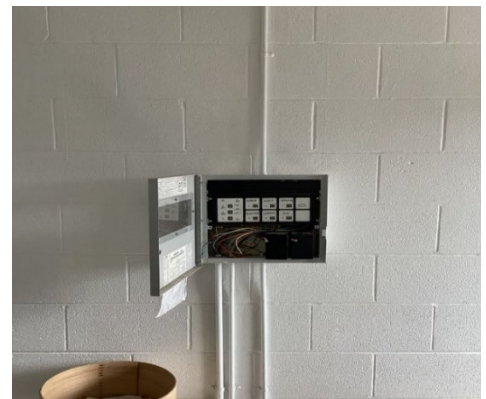
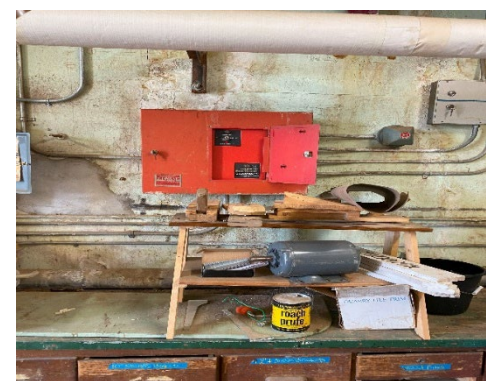
The classrooms in the original building contain standalone battery-operated smoke detectors. None of the devices tested during our walk through were in working order.

**Recommendation:** The fire alarm system is past its useful life. Install a new addressable fire alarm and detection panel, replace input and notification devices, and add devices where needed to bring the system up to current codes.

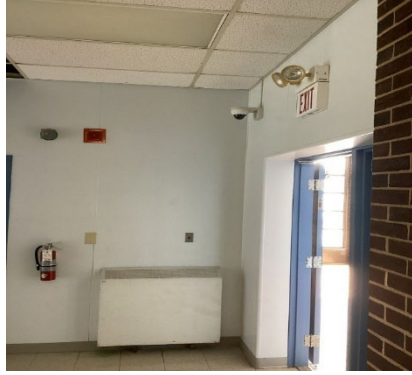
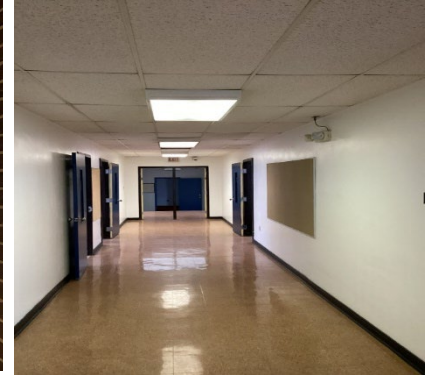
The facility does not have a standby generator. Building egress lighting uses incandescent polycarbonate combination emergency exit signs and emergency battery units. Egress lighting does not meet current code in the interior and at the exterior of the building.

**Recommendation:** Replace the interior incandescent emergency lighting fixtures with LED fixtures with battery backup. Add fixtures as need to bring the emergency egress lighting up to current requirements.

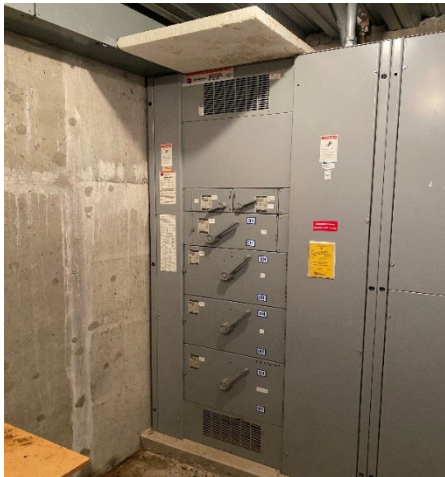
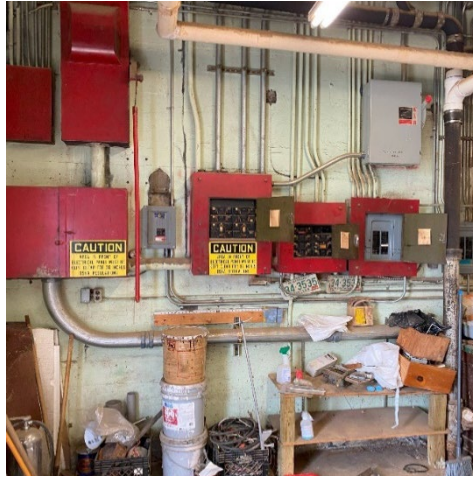
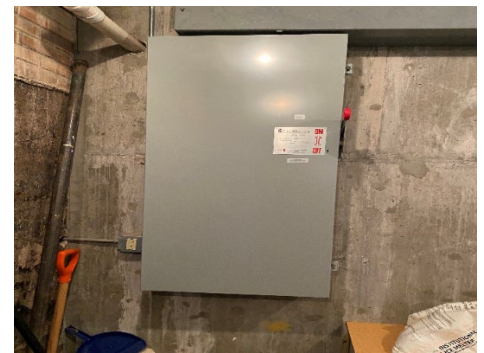
Multiple 400A main lug only Cutler Hammer panels are placed throughout the Nikander addition to feed receptacles, shop equipment and lighting branch circuits. These panels are original to the addition. The original Nikander building has multiple original branch panels and updated 100A square d panelboards on each floor.

**Recommendation:** The 1600A main service panelboard is in good condition. A single main service disconnect should be added in front of the main service panelboard for added future loads. The original distribution panelboards in the basement mechanical/electrical room will need to be replaced. To separate Mannerheim and Nikander an additional metered service will need to be installed as these buildings are currently on one electrical meter.

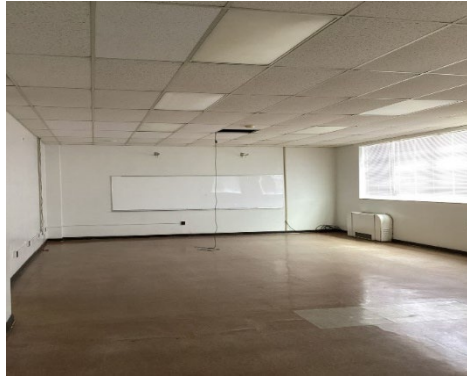
The interior lighting consists of a mix of fluorescent and incandescent light fixtures. The classrooms and corridors consist of tube type fluorescent bulbs in recessed and surface mount 24”x48” fixtures. The cafeteria and shop areas contain 8’ fluorescent pendant hung strip light fixtures. The stage area and closets consist of incandescent type fixtures.

**Recommendation:** Replace interior lighting new integral LED light fixtures in all spaces.

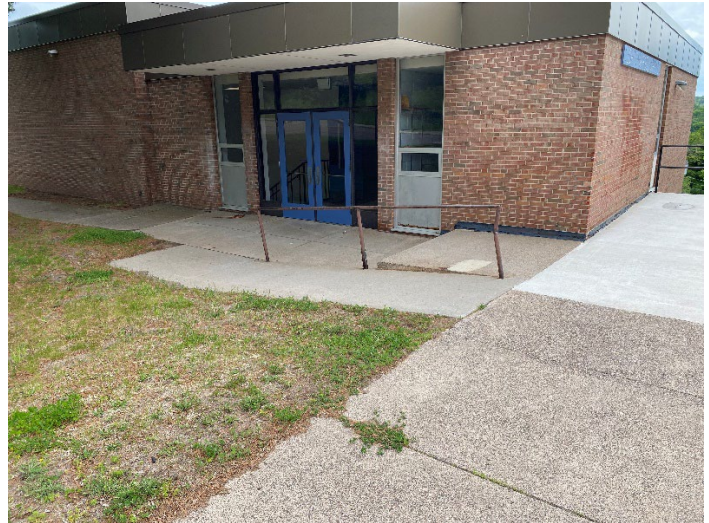
NW Entrance (Summit Street)

An approximate 21 car parking lot is located on the north side of the site, accessed from Summit Street. This lot provides access to both Wargelin and Nikander buildings. This lot is surrounded by a ~12-foot-wide sidewalk. The cross-slope of the sidewalk is greater than 2.0 percent and the ramp into the parking lot is greater than 8.33 percent, not meeting ADA guidelines. The surface of this parking lot is a mix of concrete and asphalt. This is the same parking lot addressed in the Nikander assessment. The asphalt surfaces in the parking lots are deteriorating and the grades show signs of settlement.

It is recommended to perform testing and video inspection of the storm and sanitary lines to determine the condition of the systems along with connection points. The site storm and sanitary sewers should be separated and tied into the city's respective system.

Repair the chain-link fence, miscellaneous curb-and-gutter, and sidewalk flags that have settled and broken.

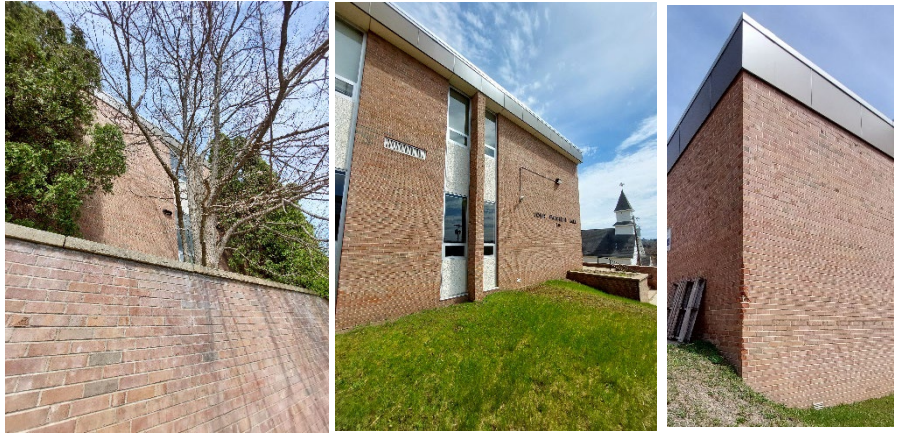
The majority of the building is faced with brick masonry in good condition. There are some small areas of brick which show efflorescence especially at the exterior retaining walls on the south side. The concrete caps on the retaining walls have open joints. There are a few small areas of damaged brick including at the southeast corner of the boiler room and on the west side at the terrace where a wall was removed. A few cracks are visible at the exterior. Additional cracks are visible at the interior of the building in the exterior CMU walls. Areas of particular note are the exterior wall of the Physics/Chemistry room on the second floor, classrooms in the Northeast corner of the first floor and the Women's bathroom on the third floor.

Re-point concrete caps at exterior retaining walls. Repair damaged masonry wall as required. Perform maintenance at building exterior, replacing existing sealants. Further investigation by a structural engineer should be performed to determine if there are underlying structural issues causing the cracking.

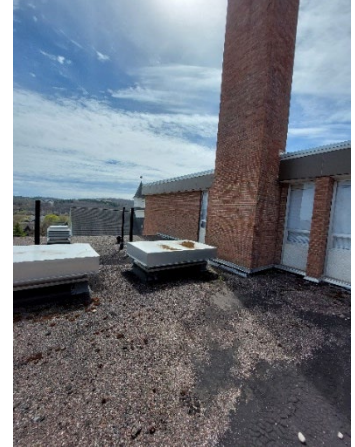
The majority of the roof surface is a loose laid EPDM membrane with rock ballast. The shows some possible shrinking at the roof edges. Seams are not visible due to the ballast. Water marks inside the building indicate that there may be leaking in areas. Insulation of the roof system over the addition (1996) is 4” of rigid insulation which was standard for that time but may not meet current Code requirements. Insulation of the roof system over the original building was originally indicated to be 1” rigid insulation. It is unknown if additional insulation was added later, but it is expected that current insulation is less than current standards and code requirements. Roof drains are present and appear to be functional. Roof drain capacity was not verified.

A section of roof above the boiler room is an asphalt built-up roof. This area is in poor condition and leaking is evident at the interior.

Replacement of the entire roof system is recommended. A fully adhered membrane system is recommended (remove all existing ballast). Additional insulation could be added during roof replacement.

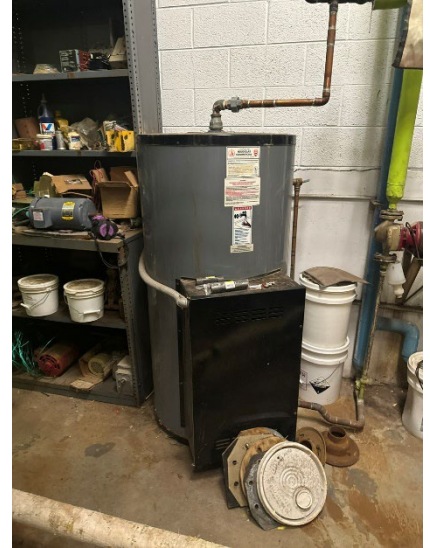
The domestic water comes into the building in the boiler room. After the meter, a pipe comes off the main and goes underground to Nikander Hall. There is an electric water heater in the boiler room that provides domestic hot water to the lavatories and sink throughout the building. The domestic water piping is copper, and the sanitary piping is cast iron. There are primary roof drains on the roof but no overflow drains. There is currently no fire suppression system in the building.

Replace all fixtures. Replace roof drains when roof is replaced and add overflow drains. Review the condition of the domestic water and sanitary piping. Replace the electric water heater with a gas water heater. Add fire suppression piping and sprinkler heads to the building.

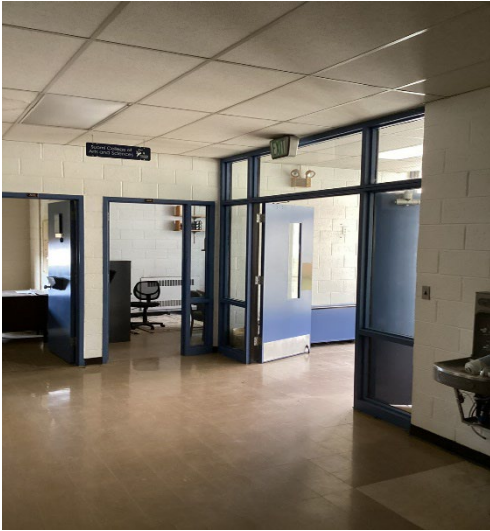
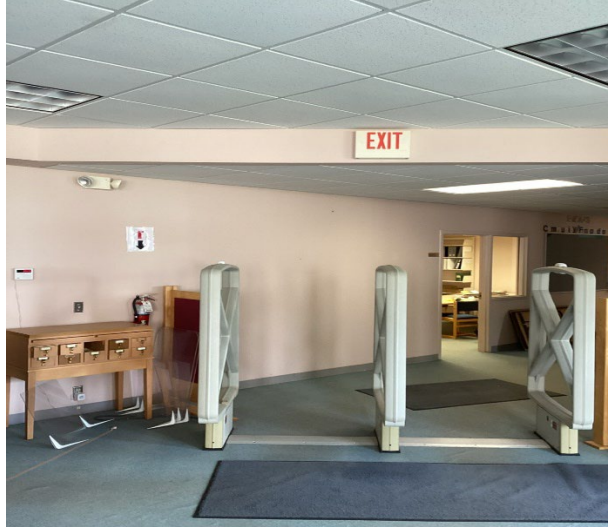
The facility does not have a standby generator. Building egress lighting uses incandescent polycarbonate combination emergency exit signs and emergency battery units. Egress lighting does not meet current code in the interior and at the exterior of the building.

**Recommendation:** Replace the interior incandescent emergency lighting fixtures with LED fixtures with battery backup. Add fixtures as needed to bring the emergency egress lighting up to current requirements.

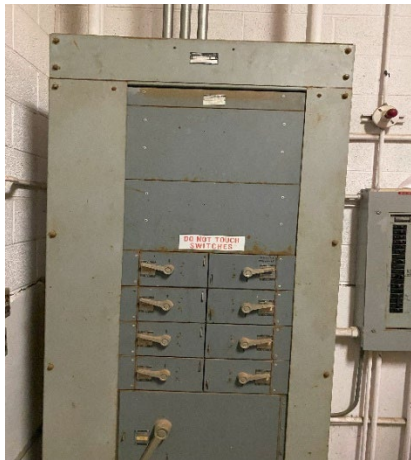
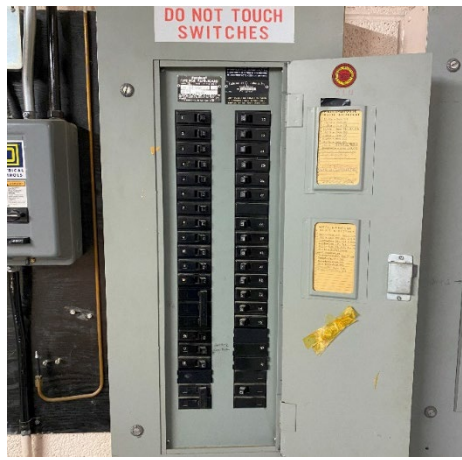
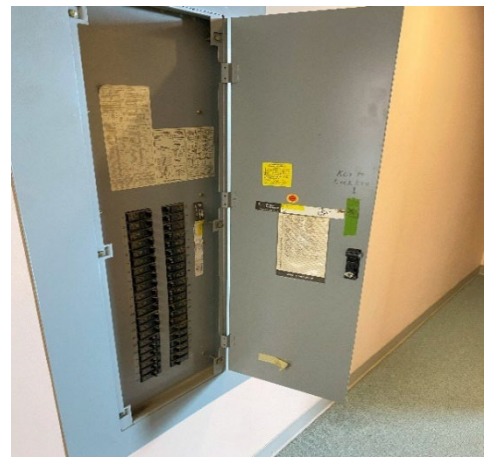
Electrical service consists of a 400A panel board containing a 400A, 208V/120V three phase fusible main service disconnect switch. The panelboard contains one section feeding multiple panels throughout the building. The panels are fed by 100A and 60A fused disconnects. The main gear is Westinghouse brand and original to the building.

**Recommendation:** The 400A main service panelboard is close to 60 years old and past its service life. This panelboard should be replaced as replacement parts will not be readily available. The Westinghouse branch panels are also 60 years old and past service life. Replace these panelboards in original locations with new. The GE panelboards are in good condition and can remain.
