June 2024

# Franklin Street Sites - Facility Assessment

Hancock MI, 49930

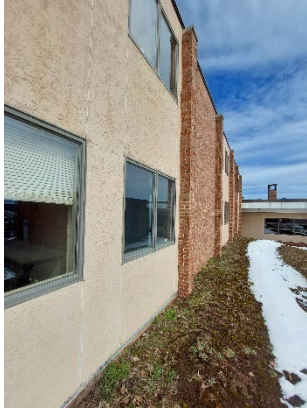
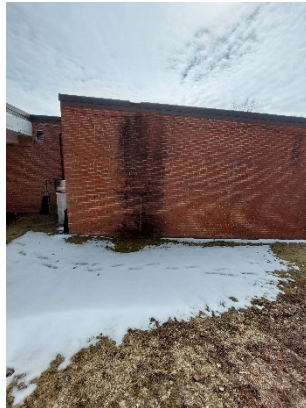
The majority of the building is faced with brick masonry and EIFS/Stucco. There are some small areas of brick which show efflorescence and some small areas in need of re-pointing. The kitchen addition is the area that has the most concern regarding the condition of the brick. It is apparent that there has been water issues and attention is needed at the scupper locations where there has been a severe degradation of the mortar joints. There is some cracking visible and some joint deterioration in the EIFS/Stucco. The EIFS/Stucco was not the original cladding of the building and the exact construction of the wall system in these areas is unknown.

Perform maintenance at building exterior, replacing existing sealants. Re-point damaged areas of brick especially at kitchen addition. Install conductors at the scuppers from the kitchen addition roof to avoid further damage to the brick surface.

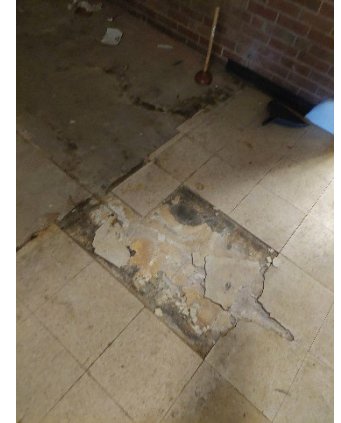
The majority of the flooring throughout the building is 9x9 tile and is in poor condition in some areas. It is expected that the floor tile may contain asbestos.

Have asbestos containing floor tile abated by a licensed abatement contractor.

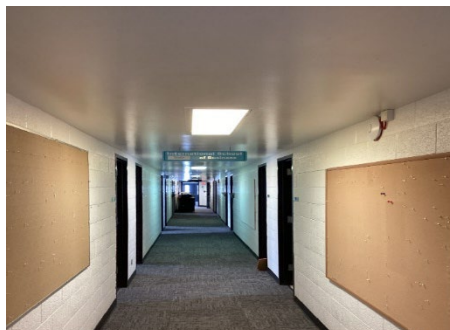
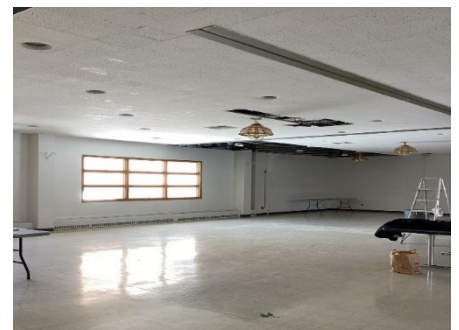
The interior lighting consists of a mix of fluorescent and incandescent light fixtures. The dormitory room lighting consists of E17 base fluorescent light bulbs in original light fixtures. The hallways consist of tube type fluorescent bulbs in recessed mount 12"x48" fixtures. The cafeteria area contains incandescent recessed can lights throughout.

**Recommendation:** Replace interior lighting in dormitory rooms with LED bulbs and new integral LED light fixtures in the hallways and cafeteria space.

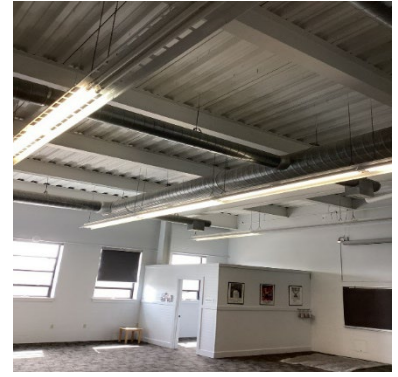
The interior lighting consists of a mix of fluorescent and incandescent light fixtures. The classrooms and corridors consist of tube type fluorescent bulbs in recessed and surface mount 24”x48” fixtures. The cafeteria and shop areas contain 8’ fluorescent pendant hung strip light fixtures. The stage area and closets consist of incandescent type fixtures.

**Recommendation:** Replace interior lighting new integral LED light fixtures in all spaces.

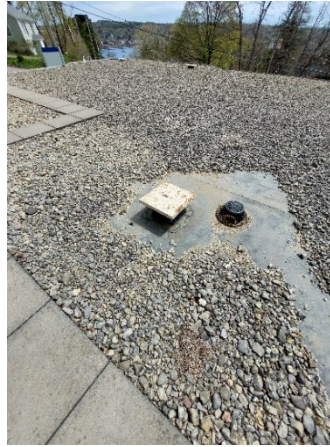
The majority of the roof surface is a loose laid EPDM membrane with rock ballast. The shows some possible shrinking at the roof edges. Seams are not visible due to the ballast. Water marks inside the building indicate that there may be leaking in areas. Insulation of the roof system over the addition (1996) is 4” of rigid insulation which was standard for that time but may not meet current Code requirements. Insulation of the roof system over the original building was originally indicated to be 1” rigid insulation. It is unknown if additional insulation was added later, but it is expected that current insulation is less than current standards and code requirements. Roof drains are present and appear to be functional. Roof drain capacity was not verified.

A section of roof above the boiler room is an asphalt built-up roof. This area is in poor condition and leaking is evident at the interior.

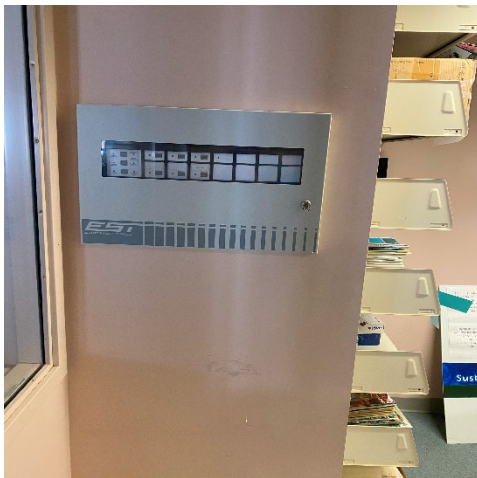
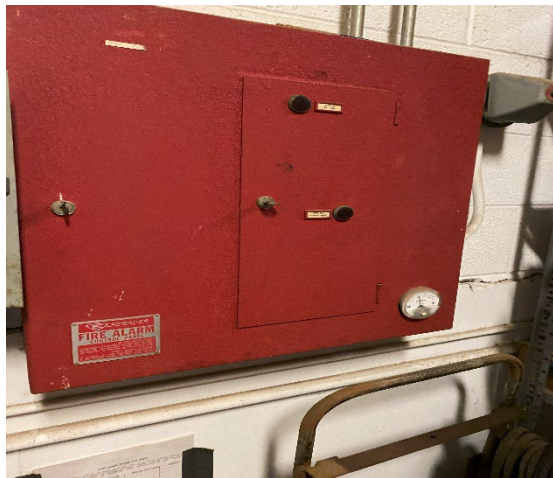
The classrooms and office spaces in the original building contain standalone battery-operated smoke detectors. None of the devices tested during our walk through were in working order.

**Recommendation:** Install a new addressable fire alarm and detection panel, replace input and notification devices, and add devices where needed to bring the system up to current codes.

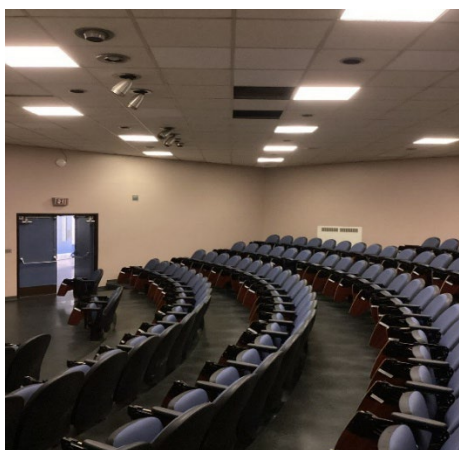
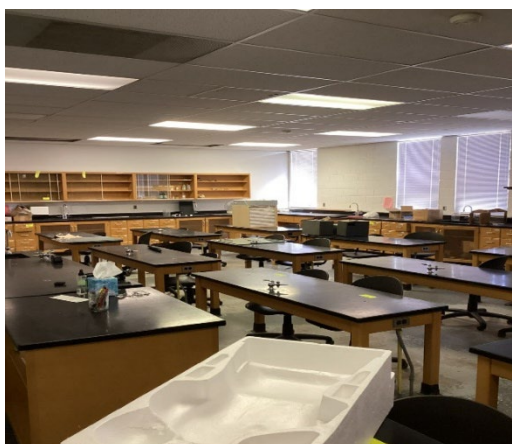
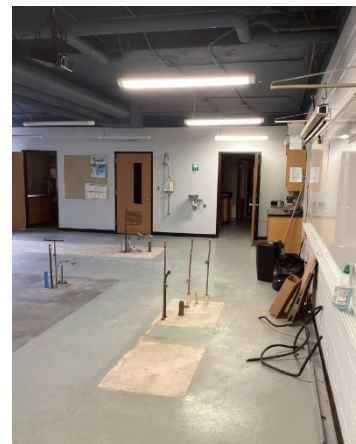
The interior lighting consists of a mix of LED, fluorescent and incandescent light fixtures. The chemistry lab contains newer led pendant light fixtures. All other classrooms, the library, offices and corridors consist of tube type fluorescent bulbs in recessed 24"x48" fixtures. The lecture hall contains 2'x2' fluorescent fixtures, incandescent recessed can lights and incandescent spotlights.

**Recommendation:** Replace interior lighting new integral LED light fixtures in all spaces.

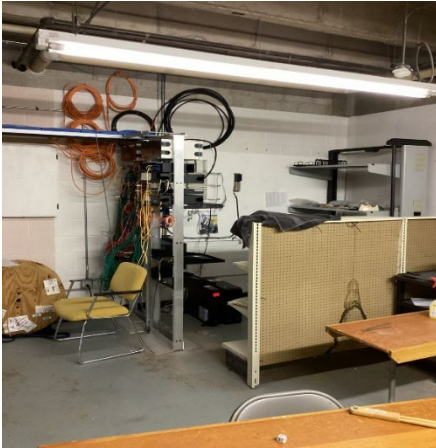
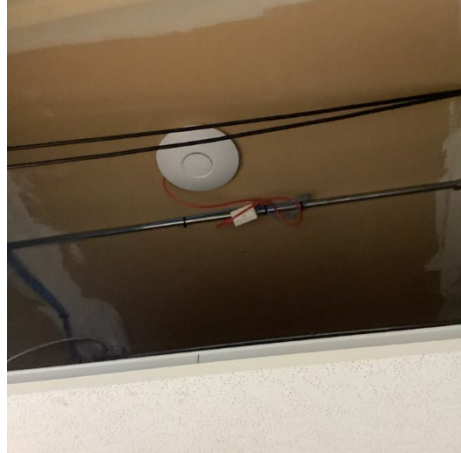
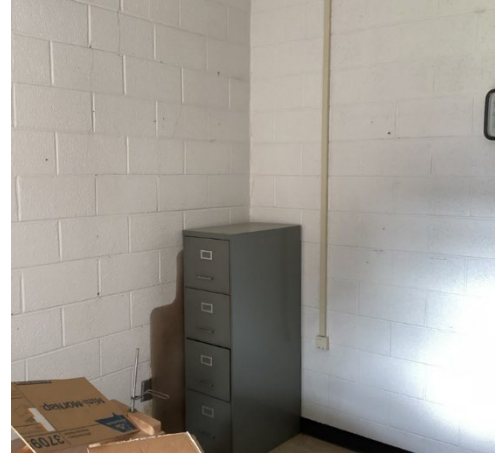
The building has an IT rack with switches, patch panels and an uninterrupted power source UPS. The rack feed data jacks located in most of the individual classrooms and wireless access points (WAPS) spread throughout the building. The rack includes cable tray for the cables routed to the IT rack. The switches in the racks are fed by a fiber optic cable. This rack contains the main feed from the utility and a fiber patch panel to feed the other buildings on campus. Existing IT infrastructure will be useable for a new system.

**Recommendation:** No current recommendations.

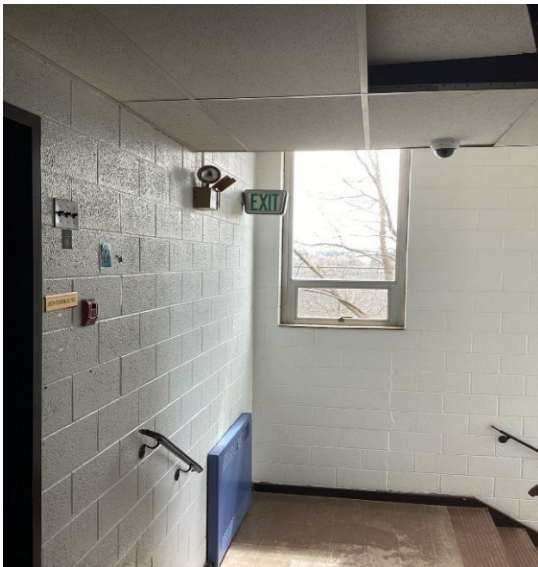
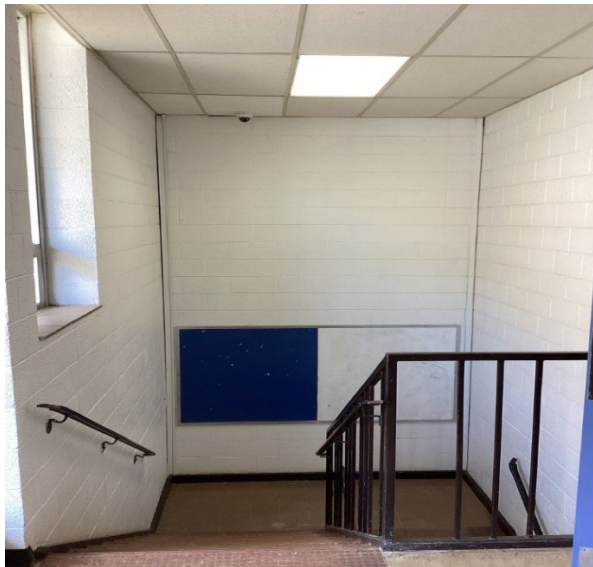
Currently there are multiple cameras in corridors and on the interior side of most exit doors.
